NOTICE TO BUYER: SELLER-PROCURED INSPECTION REPORT

Re: 11527 133rd Ave. NE
Redmond, WA.

At your request, a visual inspection of the above referenced property was conducted on 06/15/2020. We have inspected the major structural components, plumbing, heating and electrical systems for signs of significant non-performance, excessive or unusual wear and general state of repair.

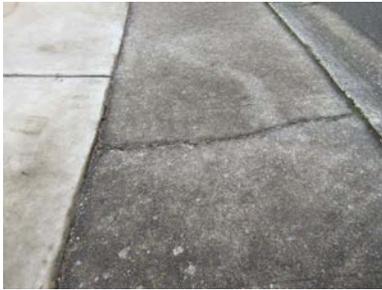
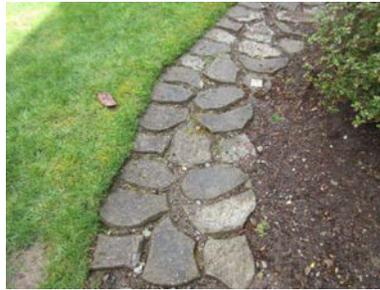
2.5 WALKWAY

The gap in the concrete walkway is a trip hazard. Replacement with mortar is recommended.

The walking surface was not even and trip hazards were present. We recommend all walking surfaces be maintained free of trip hazards.

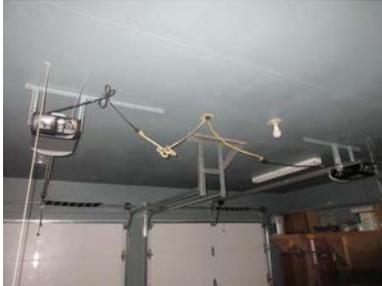
7.10 WIRING

An extension cord is used as a temporary power source for both of the garage door openers. An extension cord is not suitable as a permanent wiring method. The installation of a receptacle within cords length of the motors is recommended.

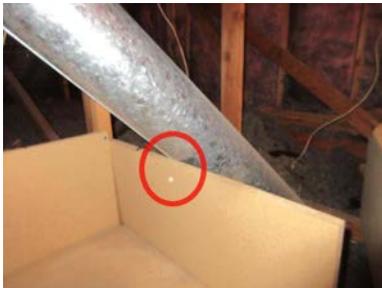
8.10 VENT

The furnace vent connector is too close to a combustible material that was observed from within the garage attic. This is a hazard. A minimum clearance of 6" is required between the single wall vent connector and the combustible material. The double wall type B vent requires only 1" of clearance. Repairs are recommended.

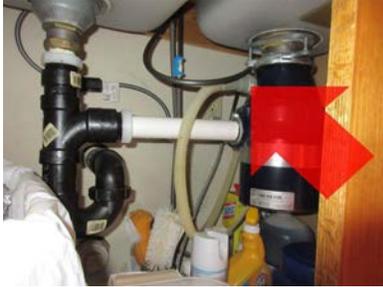
10.8 AIR GAP

The dishwasher drain lacks an air gap. The dishwasher will function without one, but there is a risk of contamination of the inside of the dishwasher by waste water. The installation of an air gap is recommended.

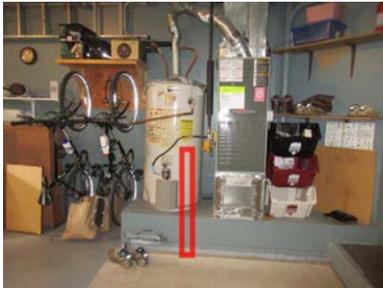
13.10 GAS PIPING

The gas pipes in front of the furnace and water heater are not protected by a bumper stop. A vertical steel pipe, bolted to the floor, is typically installed in front of the water heater to prevent a car bumper from damaging the gas lines.

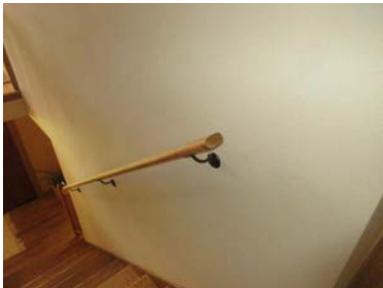
14.2 STAIRS

The railing ends in the stairwell does not return to the wall. This is a safety hazard. The installation of a continuous handrail should be considered as a safety upgrade.

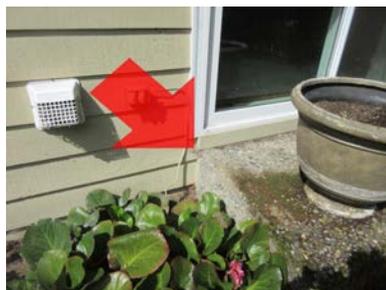
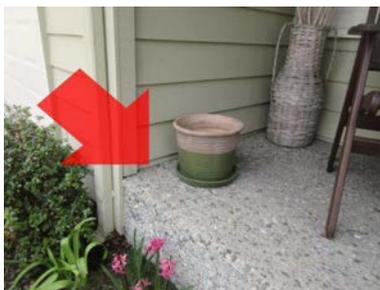
3.2 PEST CONTROL

Untreated wood in direct contact with concrete was observed along the entry stoops. Untreated wood should be raised 1-2" above the concrete. Treating the wood with a preservative sometimes will prevent wood destroy organism damage.

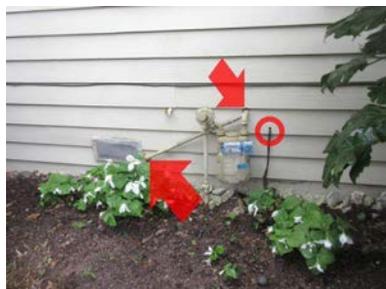
There are openings adjacent pipe and wire penetrations at the exterior wall through which rodents and other pests can enter into the structure. These openings should be covered with wood, wire mesh or filled with aerosol foam.

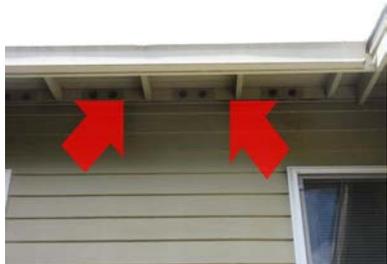
3.3 SOFFITS AND OVERHANGS

There are large gaps over 1/4" in size under the soffit vent blocks. These gaps allow insects and rodents to enter the attic. Covering the gaps with screening, a strip of wood and/or caulking is recommended.

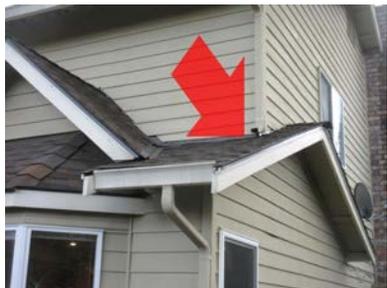
3.4 GUTTERS AND DOWNSPOUTS

Downspouts draining directly onto the asphalt shingle surface causes excessive wear of the roofing material and overflow at the gutter. Downspout extensions to the gutters should be installed to prevent excessive wear and tear of the roofing.

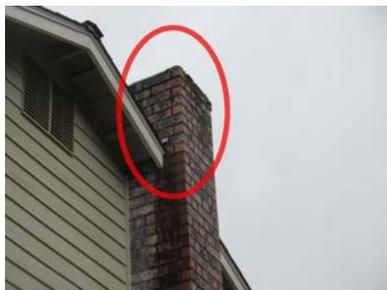
4.3 CHIMNEYS

The top of the masonry chimney does not have a spark arrestor/rain cap. The installation of a spark arrestor/rain cap is recommended as a safety upgrade and to prevent moisture damage to the inside of the chimney and fireplace. An additional benefit of a rain cap is that it will keep birds and rodents from entering the house when the damper is left open.

Moss/vegetation was observed in several areas around the upper portion of the chimney. This will lead to accelerated deterioration of the brick masonry mortar. We recommend removal of all organic growth. Damaged areas can be repaired by filling in cutout or defective mortar joints with fresh mortar. (Tuck pointing)

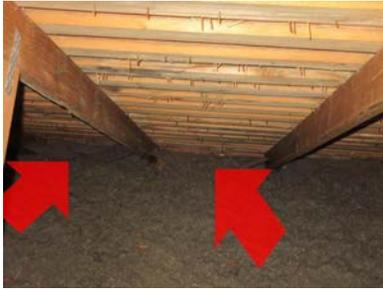
5.2 VENTILATION

Wind baffles locations are compromised in some areas of the attic. The proper placement of wind baffles in front of all soffit vents is recommended.

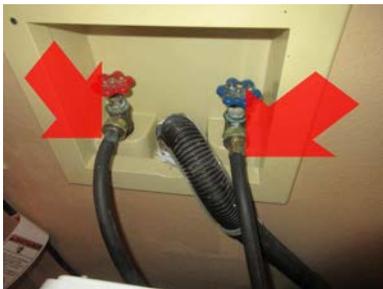
12.7 APPLIANCES

High pressure (steel braided) washer line connections is recommended.

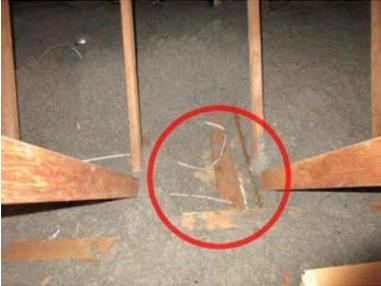
17.1 ATTIC INSULATION

There are several thermal bypasses in the attic. A thermal bypass is an opening between an insulated and uninsulated part of the house through which heated air can escape. As air is heated, it rises and pulls cool air in to the space to replace it. This condition will result in significant heat loss. Sealing up all thermal bypass routes is recommended.

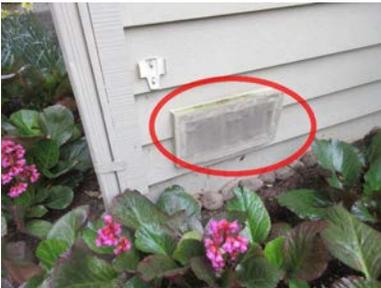
19.3 VENTILATION

The vents are covered with fine screening. This type of vent cover blocks the flow of air and the screen becomes easily clogged with dust and dirt. Better ventilation can be achieved by installing 1/4" wire mesh over the vents.

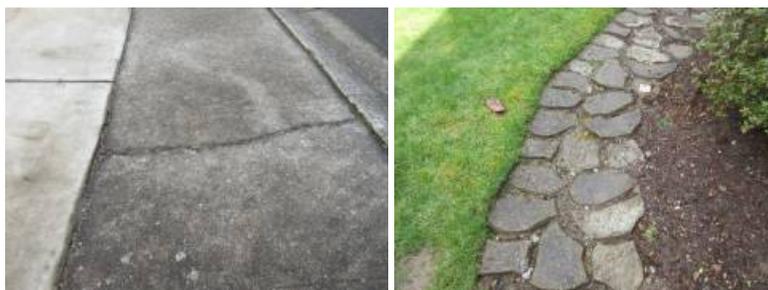
The gap in the concrete walkway is a trip hazard. Replacement with mortar is recommended.

The walking surface was not even and trip hazards were present. We recommend all walking surfaces be maintained free of trip hazards.

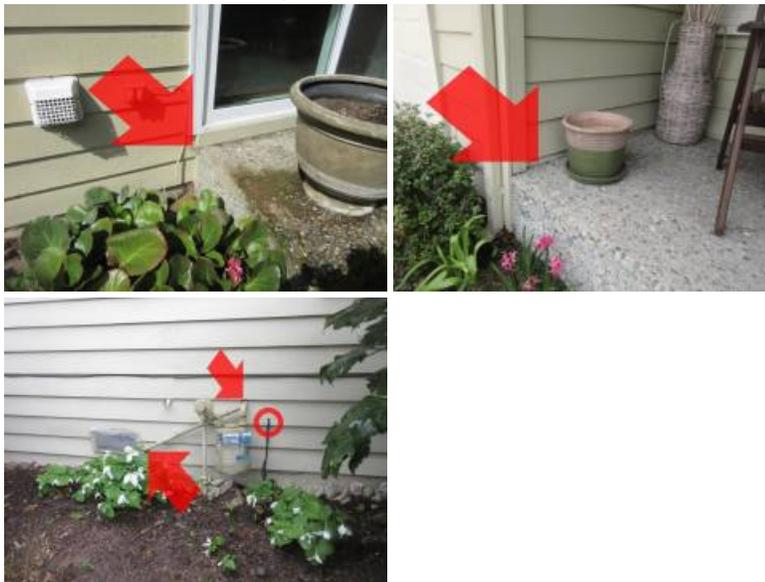
There are openings adjacent pipe and wire penetrations at the exterior wall through which rodents and other pests can enter into the structure. These openings should be covered with wood, wire mesh or filled with aerosol foam.

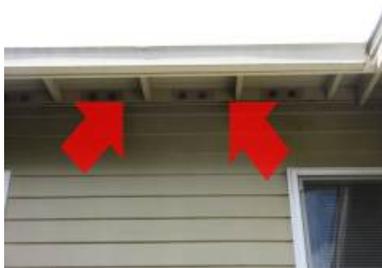
3.3 SOFFITS AND OVERHANGS

There are large gaps over 1/4" in size under the soffit vent blocks. These gaps allow insects and rodents to enter the attic. Covering the gaps with screening, a strip of wood and/or caulking is recommended.

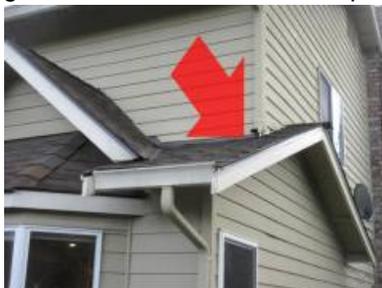
3.4 GUTTERS AND DOWNSPOUTS

Downspouts draining directly onto the asphalt shingle surface causes excessive wear of the roofing material and overflow at the gutter. Downspout extensions to the gutters should be installed to prevent excessive wear and tear of the roofing.

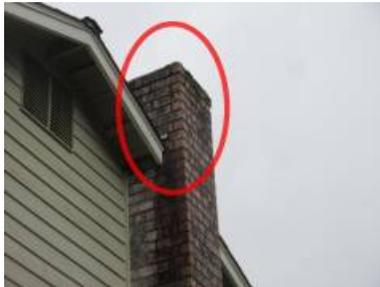
Moss/vegetation was observed in several areas around the upper portion of the chimney. This will lead to accelerated deterioration of the brick masonry mortar. We recommend removal of all organic growth. Damaged areas can be repaired by filling in cutout or defective mortar joints with fresh mortar. (Tuck pointing)

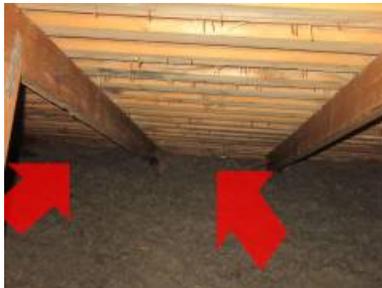
Wind baffles locations are compromised in some areas of the attic. The proper placement of wind baffles in front of all soffit vents is recommended.

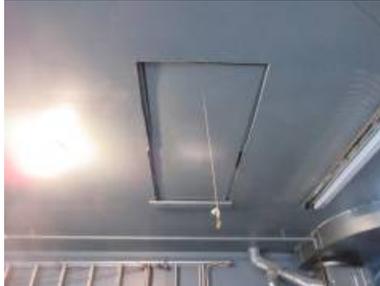
6.4 FIRE SEPARATION

The pull down ladder is a breach in the fire resistive barrier in the garage. This is a safety concern. The gypsum barrier on the ceiling slows the spread of a fire from the garage to the attic. The installation of a layer of 5/8" gypsum type X board over the 1/4" plywood is recommended.

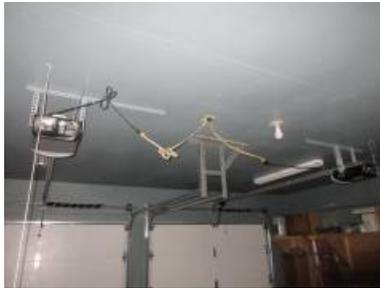
An extension cord is used as a temporary power source for both of the garage door openers. An extension cord is not suitable as a permanent wiring method. The installation of a receptacle within cords length of the motors is recommended.

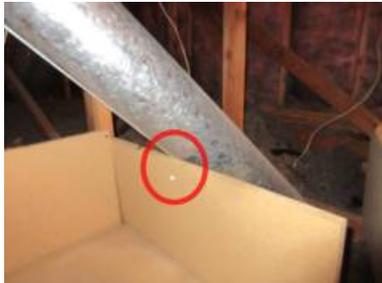
The furnace vent connector is too close to a combustible material that was observed from within the garage attic. This is a hazard. A minimum clearance of 6" is required between the single wall vent connector and the combustible material. The double wall type B vent requires only 1" of clearance. Repairs are recommended.

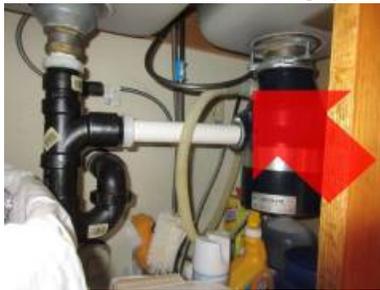
10.8 AIR GAP

The dishwasher drain lacks an air gap. The dishwasher will function without one, but there is a risk of contamination of the inside of the dishwasher by waste water. The installation of an air gap is recommended.

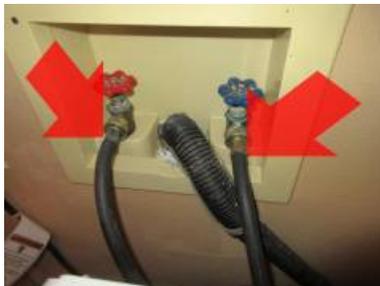
High pressure (steel braided) washer line connections is recommended.

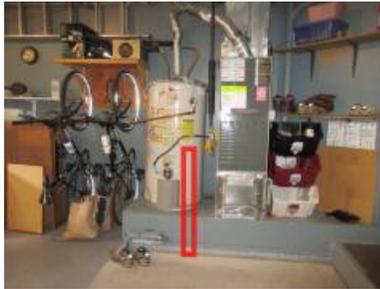
The gas pipes in front of the furnace and water heater are not protected by a bumper stop. A vertical steel pipe, bolted to the floor, is typically installed in front of the water heater to prevent a car bumper from damaging the gas lines.

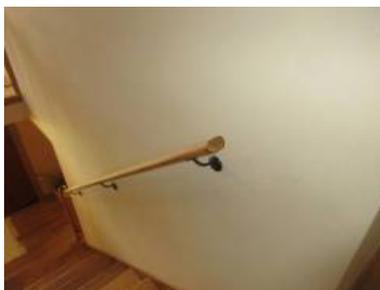
The railing ends in the stairwell does not return to the wall. This is a safety hazard. The installation of a continuous handrail should be considered as a safety upgrade.

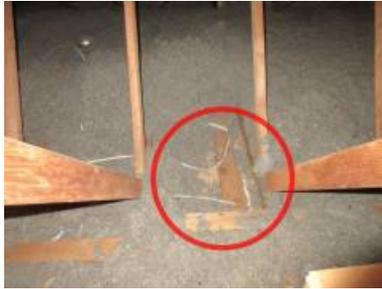
There are several thermal bypasses in the attic. A thermal bypass is an opening between an insulated and uninsulated part of the house through which heated air can escape. As air is heated, it rises and pulls cool air in to the space to replace it. This condition will result in significant heat loss. Sealing up all thermal bypass routes is recommended.

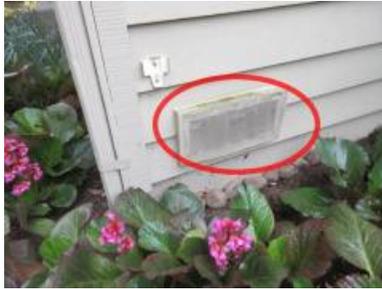
The vents are covered with fine screening. This type of vent cover blocks the flow of air and the screen becomes easily clogged with dust and dirt. Better ventilation can be achieved by installing 1/4" wire mesh over the vents.
