NOTICE TO BUYER: SELLER-PROCURED INSPECTION REPORT

The following notice is given with respect to the Purchase and Sale Agreement dated _____ between _____ (“Buyer”) and **Saul and Courtney Bailey** (“Seller”) concerning **13209 125th Ave NE Kirkland WA 98034** (“the Property”).

At your request, a visual inspection of the above referenced property was conducted on 06/05/2020. We have inspected the major structural components, plumbing, heating and electrical systems for signs of significant non-performance, excessive or unusual wear and general state of repair.

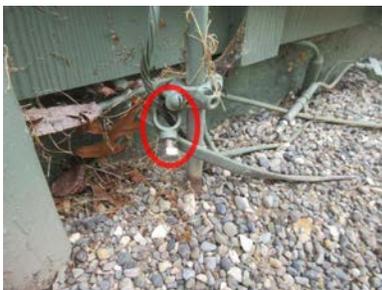
6.7 SERVICE GROUNDING AND BONDING

The service grounding electrode conductor is detached from the grounding rod. The service grounding electrode conductor should be reattached using a suitable clamp.

6.7 Service Ground and Bonding- This has been corrected.

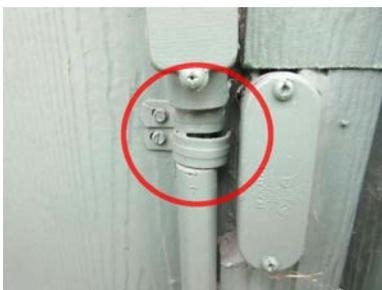
6.10 WIRING

The exterior conduit is not properly connected. This could damage the wires or cause a ground fault. The conduit connection should be made weathertight in accordance with industry standards.

6.10 Wiring- Conduit has been re-attached and made weathertight.

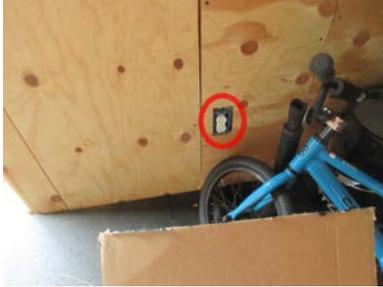
6.12 RECEPTACLES

The cover plate is missing from a receptacle in the garden tool shed. This is a shock and fire hazard. The installation of a cover plate is recommended.

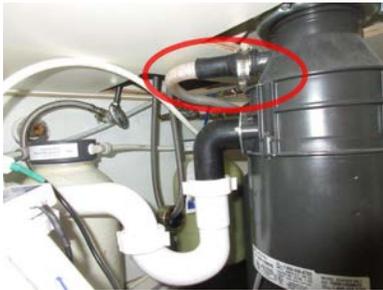
9.8 AIR GAP

The dishwasher drain lacks an air gap. The dishwasher will function without one, but there is a risk of contamination of the inside of the dishwasher by waste water. The installation of an air gap is recommended.

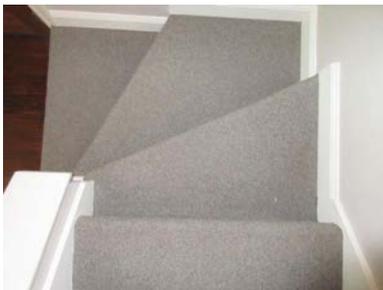
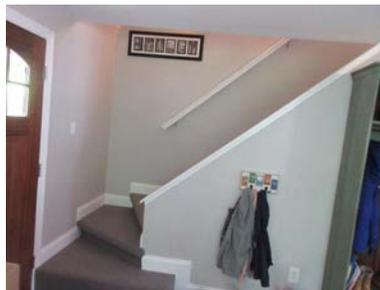
13.3 STAIRS

The run of the stairs is too short. This creates a potential trip hazard. Stair run (width of tread) should not be less than 9" with 11" being the ideal width. Consideration should be given to modifying the stairs. If this proves to be too impractical or expensive, then you should exercise extreme caution when using these stairs.

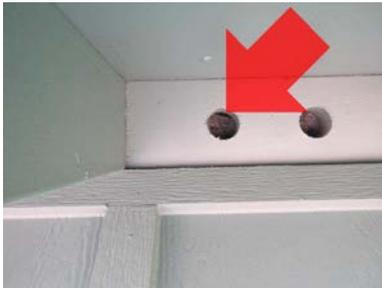
3.3 SOFFITS AND OVERHANGS

There is a damaged vent screen on the back of the house. The vent screen should be repaired to prevent insect, bird and rodent entry.

3.3 Soffits and Overhangs- This has been repaired.

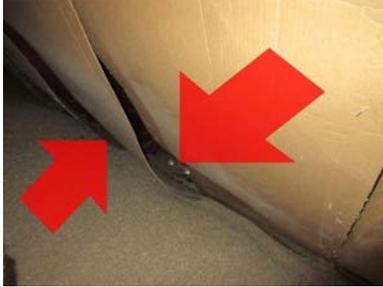
5.2 VENTILATION

Wind baffles are compromised in some areas of the attic and insulation has bypassed at several locations. Clearing away the insulation from the vent block openings and the proper placement of wind baffles in front of all soffit vents is recommended.

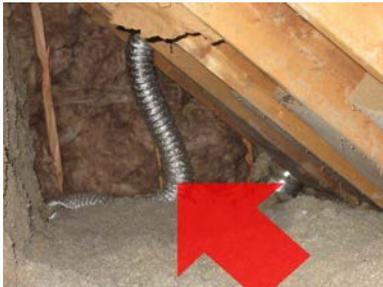
5.3 MECHANICAL VENTILATION SYSTEMS

Flexible plastic duct is used to direct air from the vent fan to the exterior. This type of material is unreliable. Replacing the plastic duct with 4" smooth-wall sheet metal duct is recommended.

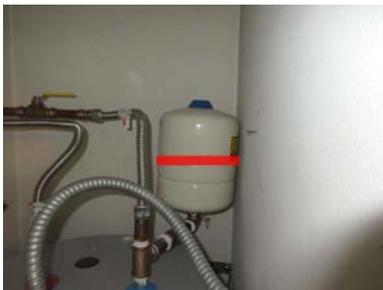
8.6 EXPANSION TANK

The expansion tank is not adequately secured to the wall. This could result in damage to the water pipe and leakage during an earth quake. A seismic restraint should be installed to secure the expansion tank.

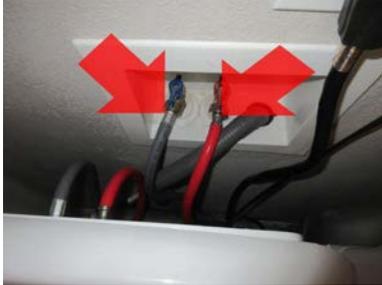
11.1 APPLIANCES

Upgrading the washer connections to high pressure (steel braided) lines is recommended.

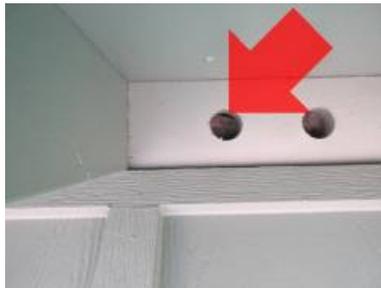
There is a damaged vent screen on the back of the house. The vent screen should be repaired to prevent insect, bird and rodent entry.

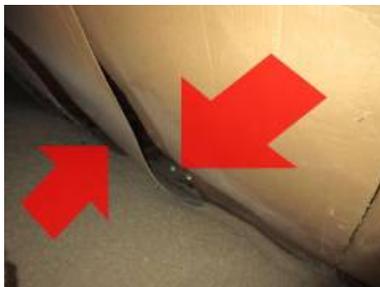
Wind baffles are compromised in some areas of the attic and insulation has bypassed at several locations. Clearing away the insulation from the vent block openings and the proper placement of wind baffles in front of all soffit vents is recommended.

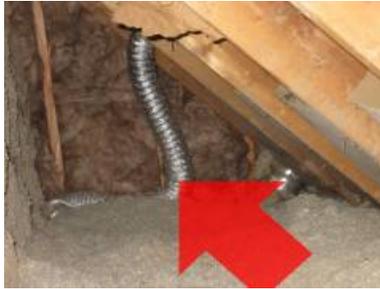
5.3 MECHANICAL VENTILATION SYSTEMS

Flexible plastic duct is used to direct air from the vent fan to the exterior. This type of material is unreliable. Replacing the plastic duct with 4" smooth-wall sheet metal duct is recommended.

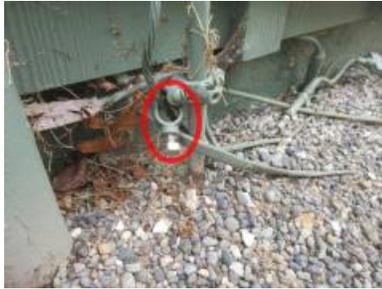
6.7 SERVICE GROUNDING AND BONDING

The service grounding electrode conductor is detached from the grounding rod. The service grounding electrode conductor should be reattached using a suitable clamp.

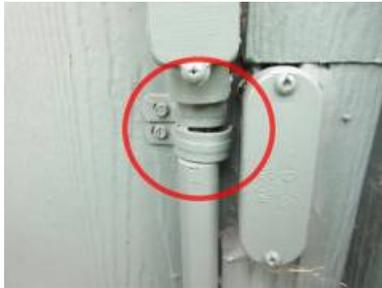
The exterior conduit is not properly connected. This could damage the wires or cause a ground fault. The conduit connection should be made weathertight in accordance with industry standards.

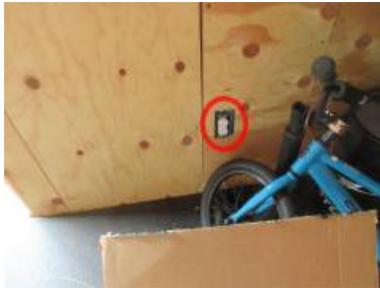
The cover plate is missing from a receptacle in the garden tool shed. This is a shock and fire hazard. The installation of a cover plate is recommended.

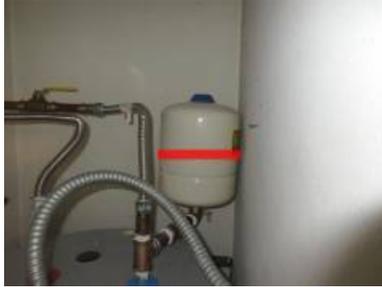
The expansion tank is not adequately secured to the wall. This could result in damage to the water pipe and leakage during an earth quake. A seismic restraint should be installed to secure the expansion tank.

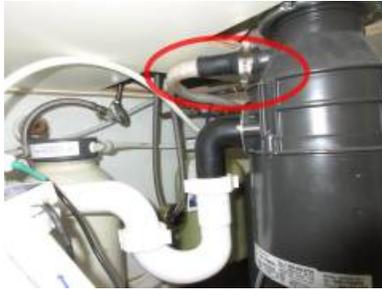
9.8 AIR GAP

The dishwasher drain lacks an air gap. The dishwasher will function without one, but there is a risk of contamination of the inside of the dishwasher by waste water. The installation of an air gap is recommended.

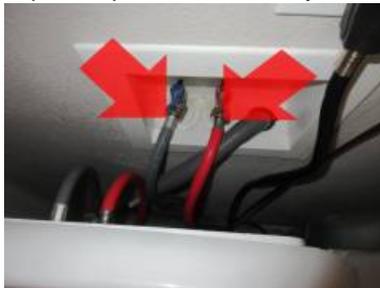
Upgrading the washer connections to high pressure (steel braided) lines is recommended.

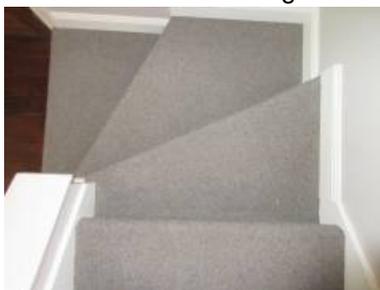
The run of the stairs is too short. This creates a potential trip hazard. Stair run (width of tread) should not be less than 9" with 11" being the ideal width. Consideration should be given to modifying the stairs. If this proves to be too impractical or expensive, then you should exercise extreme caution when using these stairs.

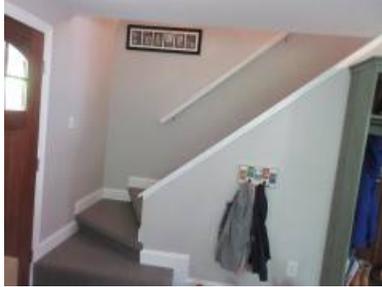
13.4 GUARD RAILINGS

There is no guardrail at the stairs. This is a safety hazard. The installation of a guardrail that conforms to present industry standards is recommended.
