**NOTICE TO BUYER: SELLER-PROCURED INSPECTION REPORT**

**Dave and Lori Anderson**  
**22533 165<sup>th</sup> Ave SE**  
**Monroe, WA 98272**

At your request, a visual inspection of the above referenced property was conducted on 01/24/2020. We have inspected the major structural components, plumbing, heating and electrical systems for signs of significant non-performance, excessive or unusual wear and general state of repair.

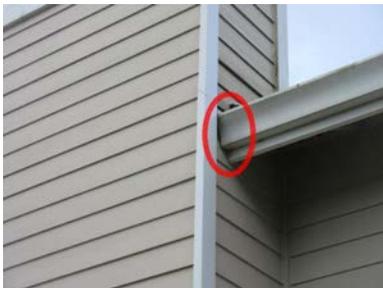
#### *3.5 GUTTERS AND DOWNSPOUTS*

Gutter ends are too close to the siding. Gutter ends should be installed with a 1" clearance from cement fiber board siding. Gutters should be cleaned regularly to prevent clogging and overflow.

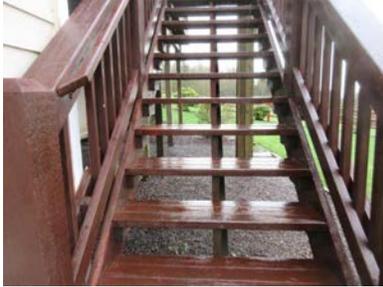
#### *3.9 STAIRS*

The stair rise spacing is too wide. This is a hazard for small children. The spacing should be reduced as a safety upgrade. Current standards require that a 4" sphere not pass through the opening.

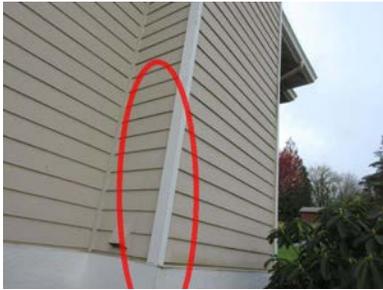
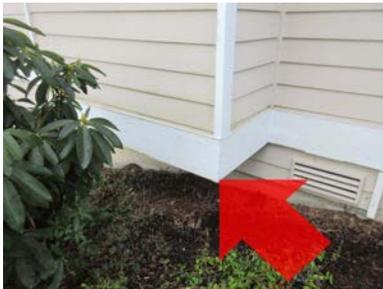
### 4.4 FLASHINGS

There are no kick out flashings at the roof edge to wall intersections above the gutters. This will allow water to enter the wall behind the siding. The installation of kick-out flashings is recommended.

The flashing at the roof edge to chimney intersection above the gutter is allowing water to enter the wall behind the siding. Flashing repairs are recommended.

4.4 Flashings installed

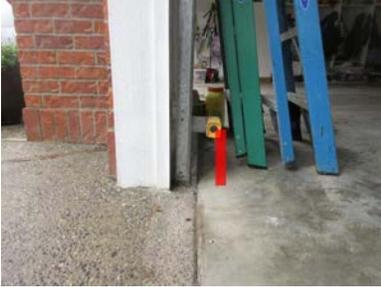
#### 6.3 GARAGE DOOR OPENER

The Photo-eye beam was installed too high above the floor of the garage to adequately offer protection for small children and/or pets. We recommend that the photo-eye be lowered to within 4-6" of the floor.

6.3 Garage door photo eye relocated

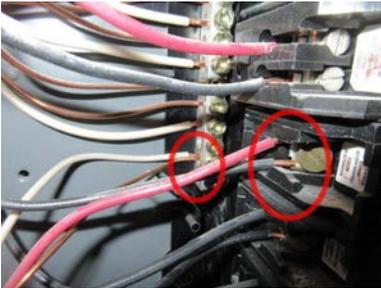
One of the neutral wires is double tapped with a ground wire on the buss bar. Double tapping means that two conductors share a single terminal. Double tapped terminals can loosen and overheat and therefore are not permitted. This defect is easily repaired by separating the two wires.

The subpanels grounding and neutral buss bar is now one unit since the grounds and neutrals are connected. This is a potential shock hazard. . The neutral buss bar should be separate from the grounding buss bar. The grounding buss bar should be bonded to the panel and the neutral buss bar insulated from the panel. The services of a qualified electrical contractor should be retained for repairs.

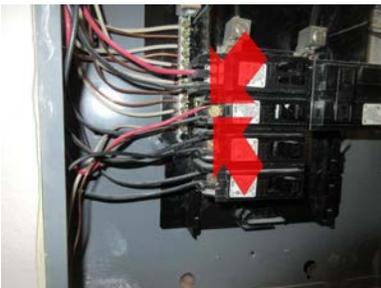
### 7.11 OVER CURRENT PROTECTION

One of the circuits is double tapped at the lower level sub panel with different sized wires. Double tapping means that two conductors share a single terminal. Double tapped terminals can loosen and overheat and therefore are not permitted unless the terminal is specifically listed for multiple size wires. This defect is easily repaired by connecting the two wires to a "pig tail", securing them with a wire cap, and then inserting the pig tail conductor under the terminal.

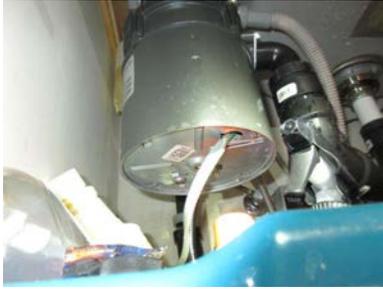
### 7.12 WIRING

The cord is not clamped where it enters the disposal. This could damage the wires or cause a ground fault.

The cord should be clamped in accordance with industry standards.

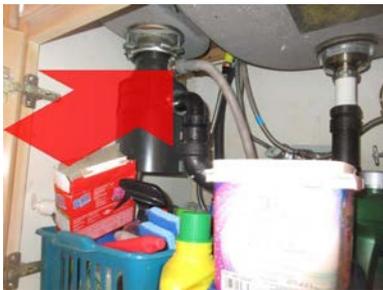
#### 11.8 AIR GAP

The dishwasher drain lacks an air gap. The dishwasher will function without one, but there is a risk of contamination of the inside of the dishwasher by waste water. The installation of an air gap is recommended.

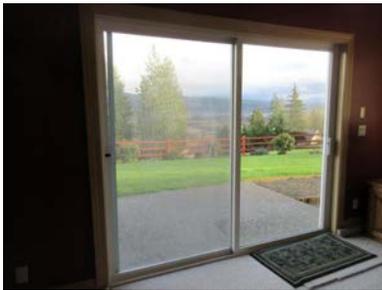
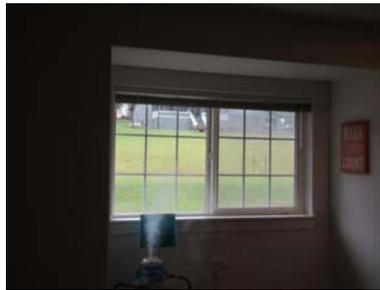
### *15.8 WINDOWS*

There is condensation or mineral deposits between the panes of glass in several of the insulated glass windows. This indicates failed seals. The glass assemblies should be replaced, which is the only method for correcting this deficiency.

15.8 glass replaced

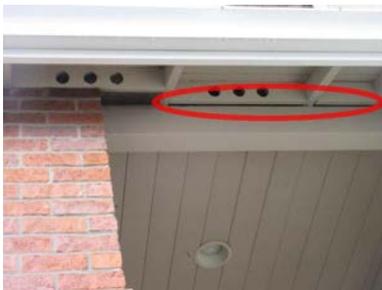
There are large gaps over 1/4" in size adjacent the soffit vent blocks. These gaps allow insects and rodents to enter the attic. Covering the gaps with screening, a strip of wood and/or caulking is recommended.

The ends of the barge boards are exposed to the weather and are vulnerable to rot damage. To prevent damage to the barge board ends, they should be covered with roofing material or flashing.

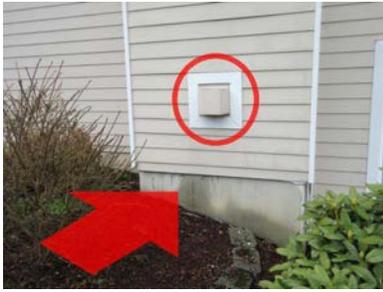
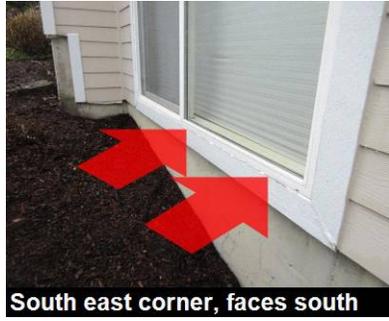
### **3.6 PAINT**

The bottom edge of the lower sections of siding on the exterior are unprotected. Paint protects the siding from moisture absorption and its propensity to hold paint. Painting of the exposed edges is recommended.

The caulking is cracked and deteriorated. Caulking prevents water intrusion into the wall. Removing and replacing deteriorated caulk is recommended.

Exterior wall penetrations sealed with caulking will shrink, crack and eventually will leak. This could result in interior water intrusion. The installation of head flashings is recommended.

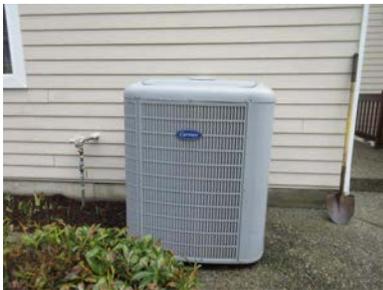
**9.2 CONDENSER**

The concrete supporting the outdoor condensing unit has settled, leaving it out of level. The connections can be stressed and accelerated wear of the bearings and other components may occur. The unit should be leveled.

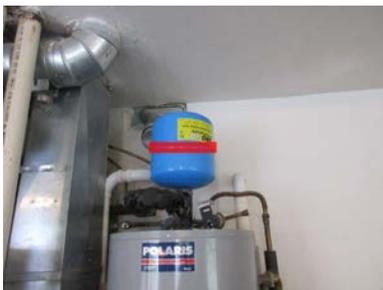
**10.6 EXPANSION TANK**

The expansion tank is not adequately secured to the wall. This could result in damage to the water pipe and leakage during an earth quake. A seismic restraint should be installed to secure the expansion tank.

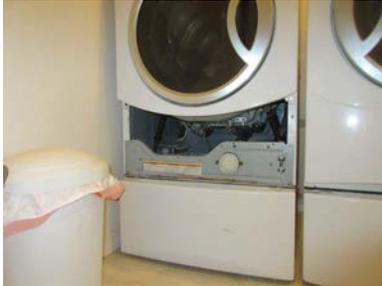
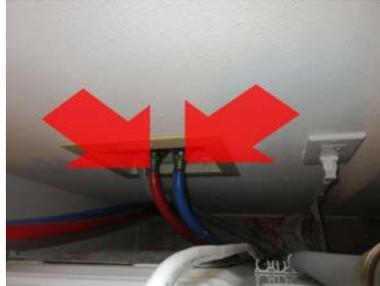
### 13.8 APPLIANCES

Upgrading the washer connections to high pressure (steel braided) lines is recommended.

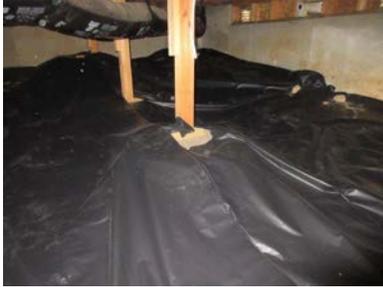
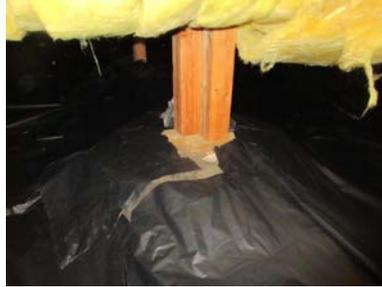
### 20.4 VAPOR RETARDER

The support post concrete piers are covered with the plastic vapor retarder. This allows the transmission of water vapor from the soil up and into the floor framing. The plastic vapor retarder should be removed from the pier so that it covers at least 85% of the entire surface of the soil only.

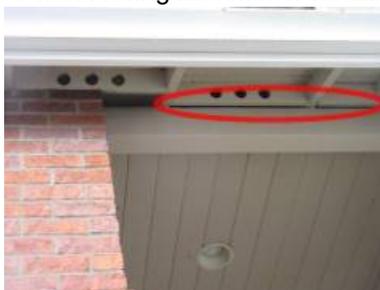
The ends of the barge boards are exposed to the weather and are vulnerable to rot damage. To prevent damage to the barge board ends, they should be covered with roofing material or flashing.

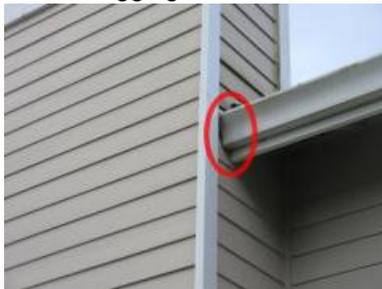
### 3.5 GUTTERS AND DOWNSPOUTS

Gutter ends are too close to the siding. Gutter ends should be installed with a 1" clearance from cement fiber board siding. Gutters should be cleaned regularly to prevent clogging and overflow.

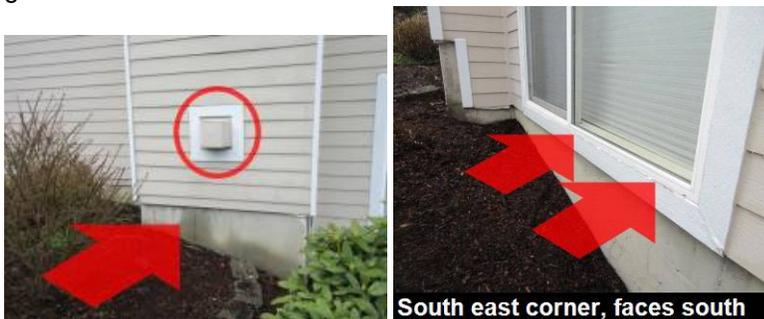
### 3.6 PAINT

The bottom edge of the lower sections of siding on the exterior are unprotected. Paint protects the siding from moisture absorption and its propensity to hold paint. Painting of the exposed edges is recommended.

Exterior wall penetrations sealed with caulking will shrink, crack and eventually will leak. This could result in interior water intrusion. The installation of head flashings is recommended.

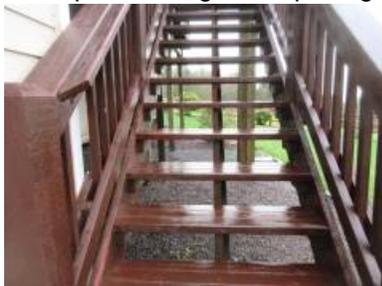
The stair rise spacing is too wide. This is a hazard for small children. The spacing should be reduced as a safety upgrade. Current standards require that a 4" sphere not pass through the opening.

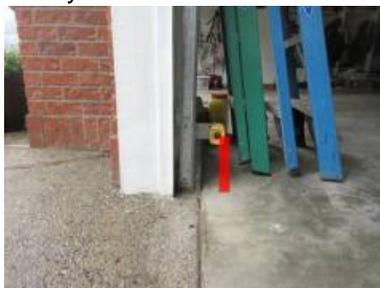
The Photo-eye beam was installed too high above the floor of the garage to adequately offer protection for small children and/or pets. We recommend that the photo-eye be lowered to within 4-6" of the floor.

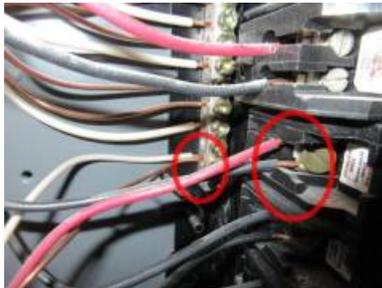
The subpanels grounding and neutral buss bar is now one unit since the grounds and neutrals are connected. This is a potential shock hazard. . The neutral buss bar should be separate from the grounding buss bar. The grounding buss bar should be bonded to the panel and the neutral buss bar insulated from the panel. The services of a qualified electrical contractor should be retained for repairs.

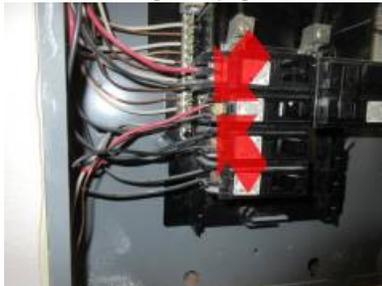
### 7.11 OVER CURRENT PROTECTION

One of the circuits is double tapped at the lower level sub panel with different sized wires. Double tapping means that two conductors share a single terminal. Double tapped terminals can loosen and overheat and therefore are not permitted unless the terminal is specifically listed for multiple size wires. This defect is easily repaired by connecting the two wires to a "pig tail", securing them with a wire cap, and then inserting the pig tail conductor under the terminal.

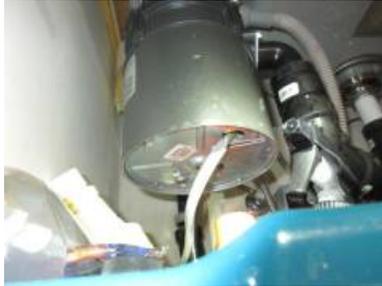
### 7.12 WIRING

The cord is not clamped where it enters the disposal. This could damage the wires or cause a ground fault. The cord should be clamped in accordance with industry standards.

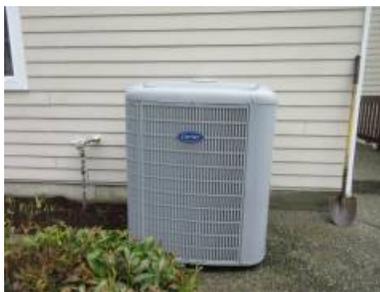
One of the only ways to make sure that the condenser oil stays moves smoothly and mostly deposits in the compressor is to keep the unit upright and level.

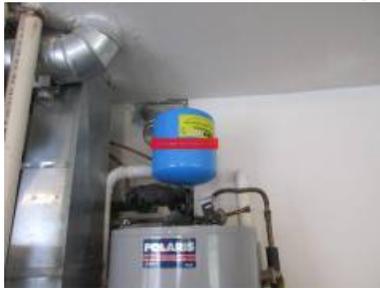
The expansion tank is not adequately secured to the wall. This could result in damage to the water pipe and leakage during an earth quake. A seismic restraint should be installed to secure the expansion tank.

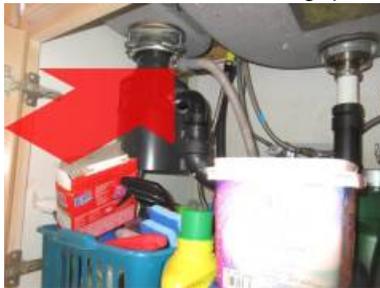
The dishwasher drain lacks an air gap. The dishwasher will function without one, but there is a risk of contamination of the inside of the dishwasher by waste water. The installation of an air gap is recommended.

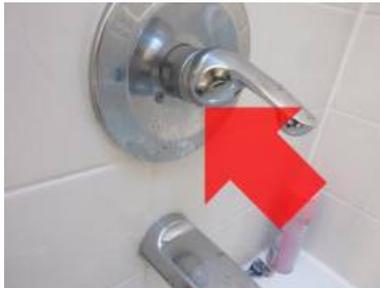
The bathtub faucet valve stem is leaking. This is indicative of a worn valve. Repair or replacement of the valve is recommended.

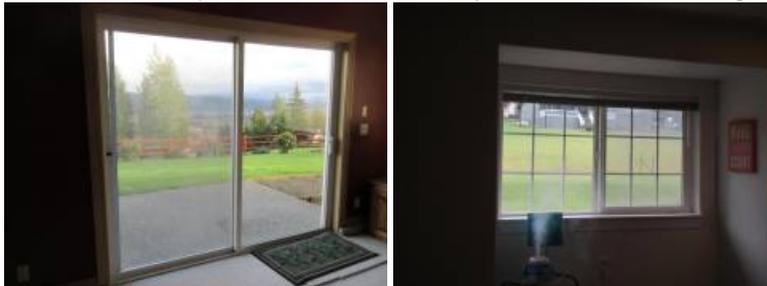
There is condensation or mineral deposits between the panes of glass in several of the insulated glass windows. This indicates failed seals. The glass assemblies should be replaced, which is the only method for correcting this deficiency.

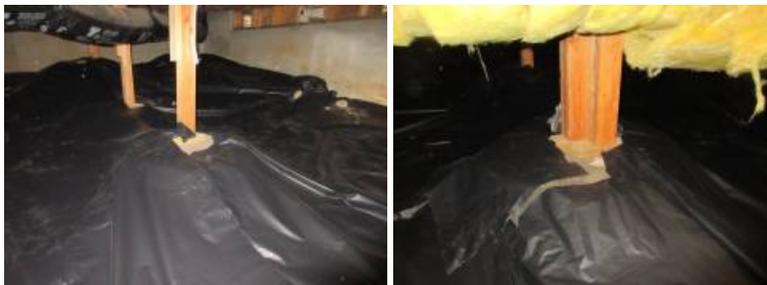
The support post concrete piers are covered with the plastic vapor retarder. This allows the transmission of water vapor from the soil up and into the floor framing. The plastic vapor retarder should be removed from the pier so that it covers at least 85% of the entire surface of the soil only.
