**NOTICE TO BUYER: SELLER-PROCURED INSPECTION REPORT**

**Dave and Lori Anderson**  
**22533 165<sup>th</sup> Ave SE**  
**Monroe, WA 98272**

At your request, a visual inspection of the above referenced property was conducted on 01/24/2020. We have inspected the major structural components, plumbing, heating and electrical systems for signs of significant non-performance, excessive or unusual wear and general state of repair.

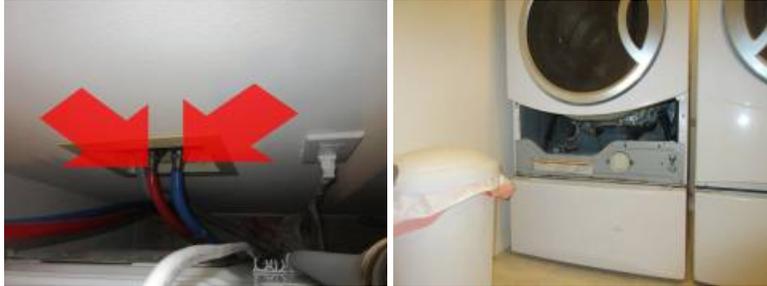
The hookups for the dryer are properly installed and in serviceable condition. The dryer itself was operated through a partial cycle, however we did not confirm the complete operation of the cycle timer.

Replacing missing access panels and/or covers is recommended.
